# Annual Report for FY14 NPDES Municipal Separate Storm Sewer System Permit

Published by the Montgomery County Department of Environmental Protection  
for the Maryland Department of the Environment

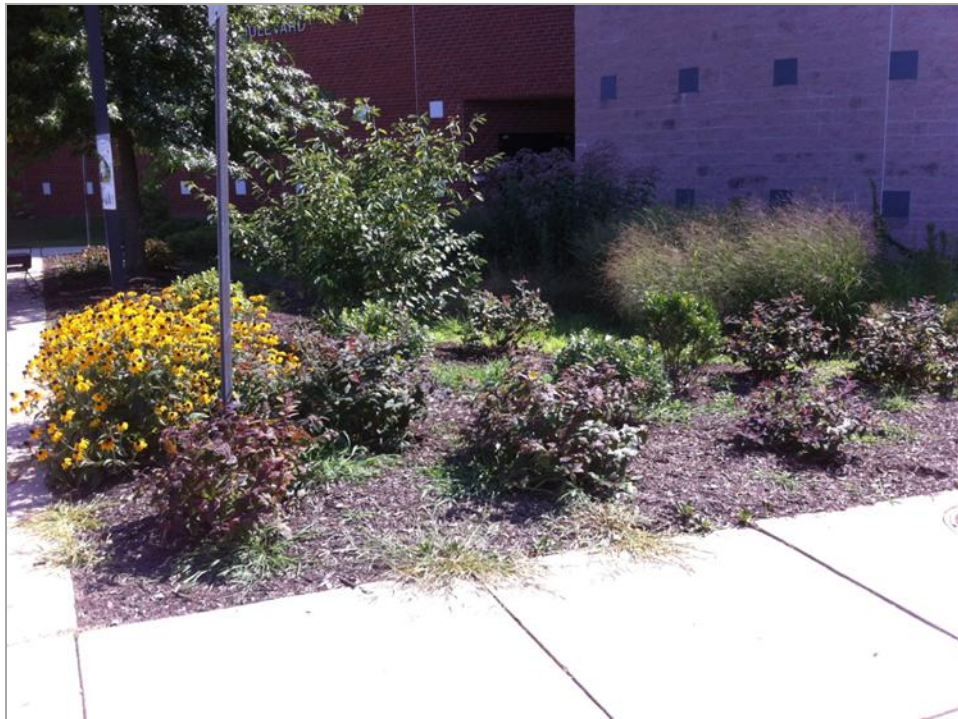
**Figure III.E.26. RainScapes for Schools Conservation Landscape Garden Filtering Water Before it Enters the Storm Drain System at Montgomery Blair High School**

RainScapes for Schools projects have included both conservation landscapes and rain gardens for curriculum support and runoff reduction (Figure III.E26). Some schools have done more than one project; since 2008, the RainScapes program has supported 15 Montgomery County public school based projects.

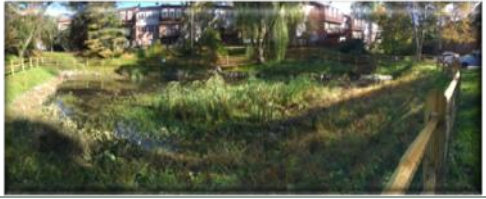
Table III.G.9. Highlighted Watershed Restoration Projects for FY14			
	Project Name	Impervious Acres Captured	Photo
Stormwater Pond	Georgian Colonies	5 Acres

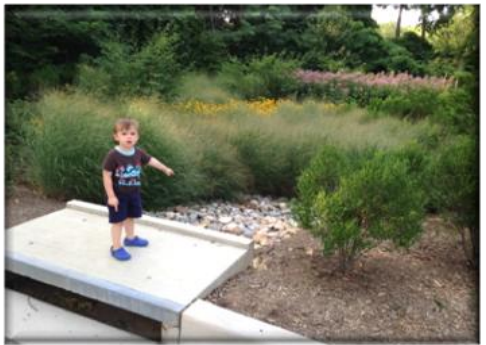
Stream	Donnybrook Stream Restoration	19.64 Acres	 
Public Property Low Impact Development (LID)	Kensington Library	0.67 Acres

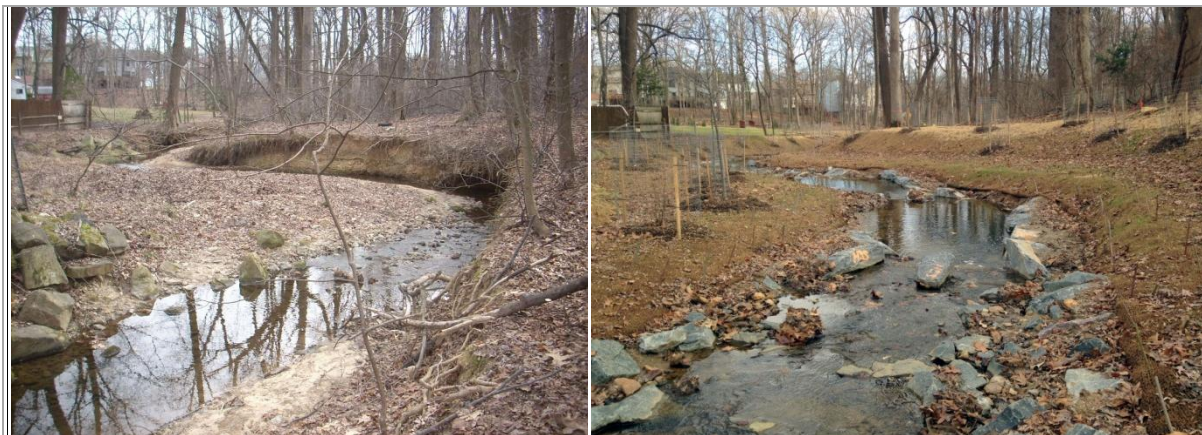
**Figure III.G.2. Pre-restoration (left) and Post-restoration Conditions (right) at Hollywood Branch (Photos taken: 8/30/11 and 12/18/14 respectively)**

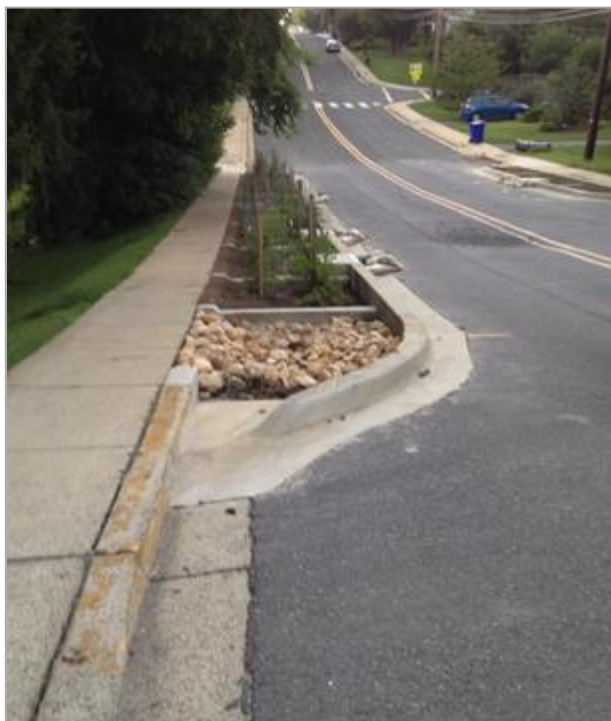
**Figure III.G.5. Recently Completed Donnybrook Green Streets Neighborhood Curb Extensions, Located on Grubb Road (Photo taken 7/15/14)**

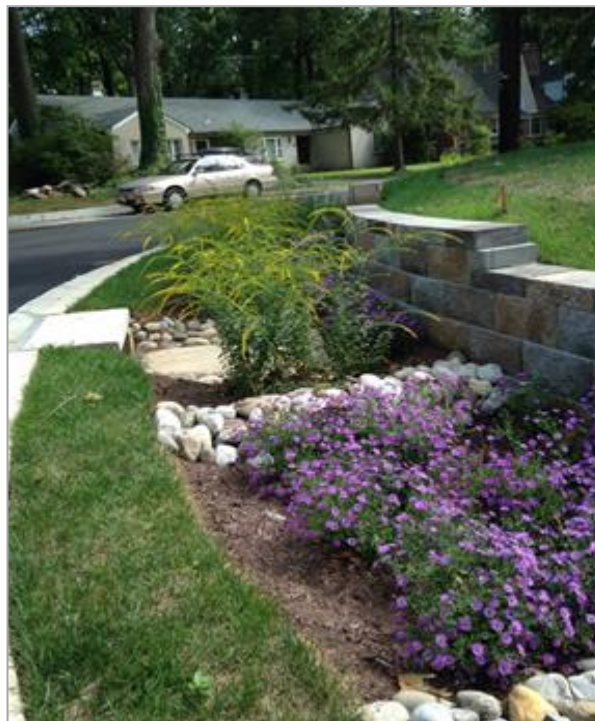
**Figure III.G.6. Recently Completed Sligo Park Hills Green Streets Project Located on Wessex Road (Photo taken 9/11/14)**

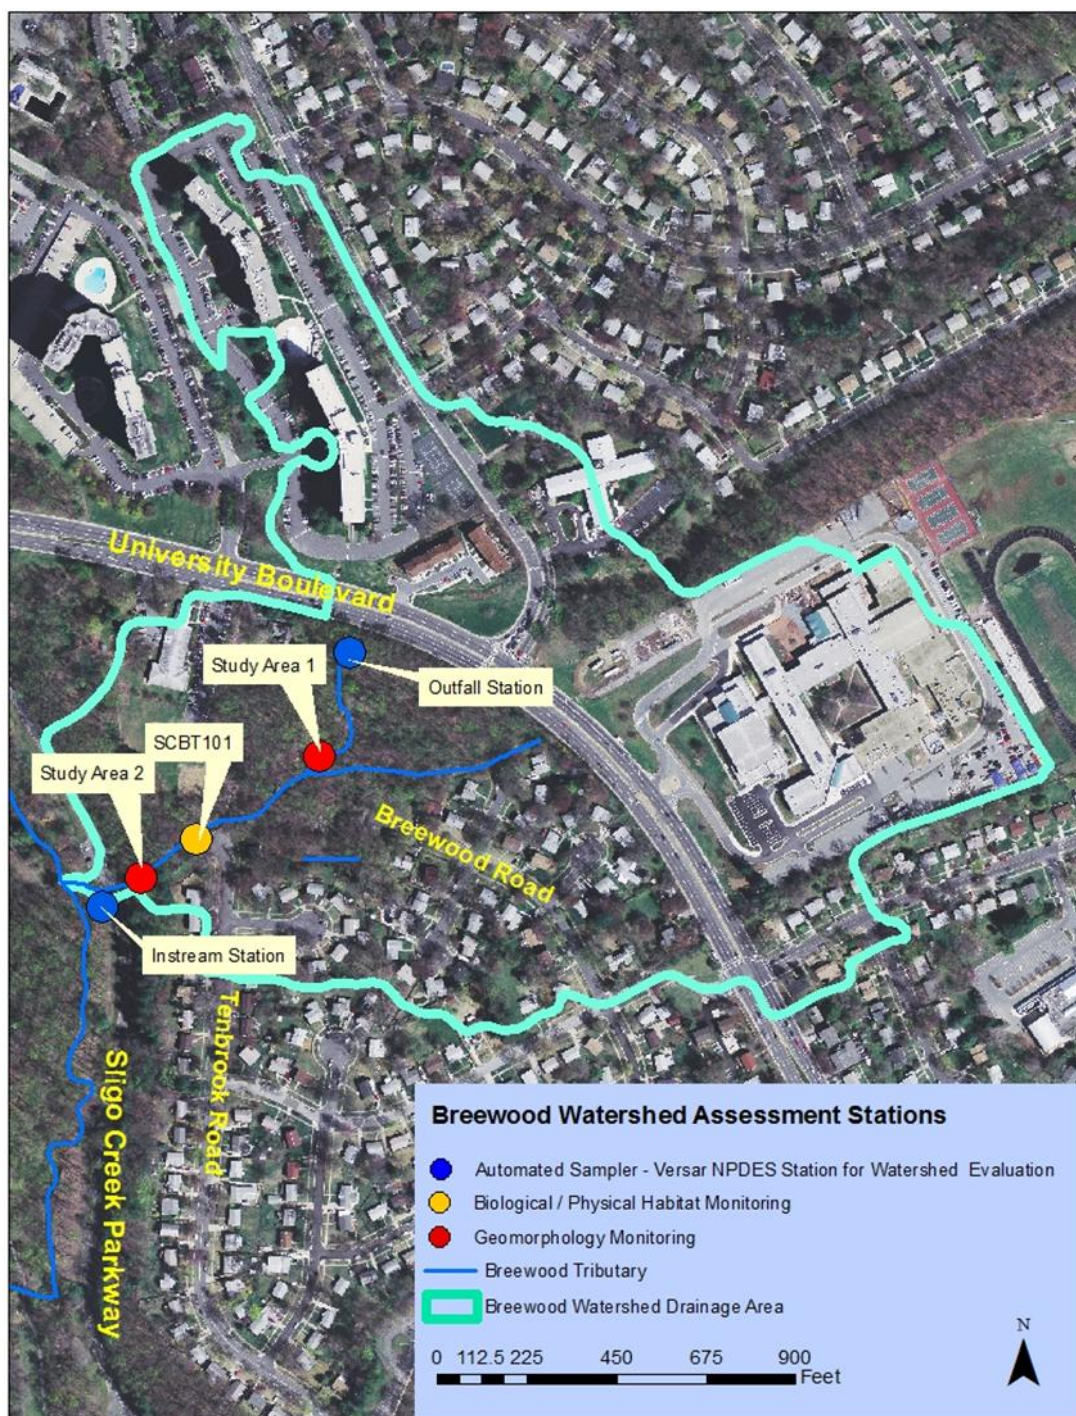
**Figure III.H.2. Locations of Stream Chemistry, Biological, Physical Habitat and Geomorphology Monitoring Stations, Breewood Tributary of Sligo Creek**

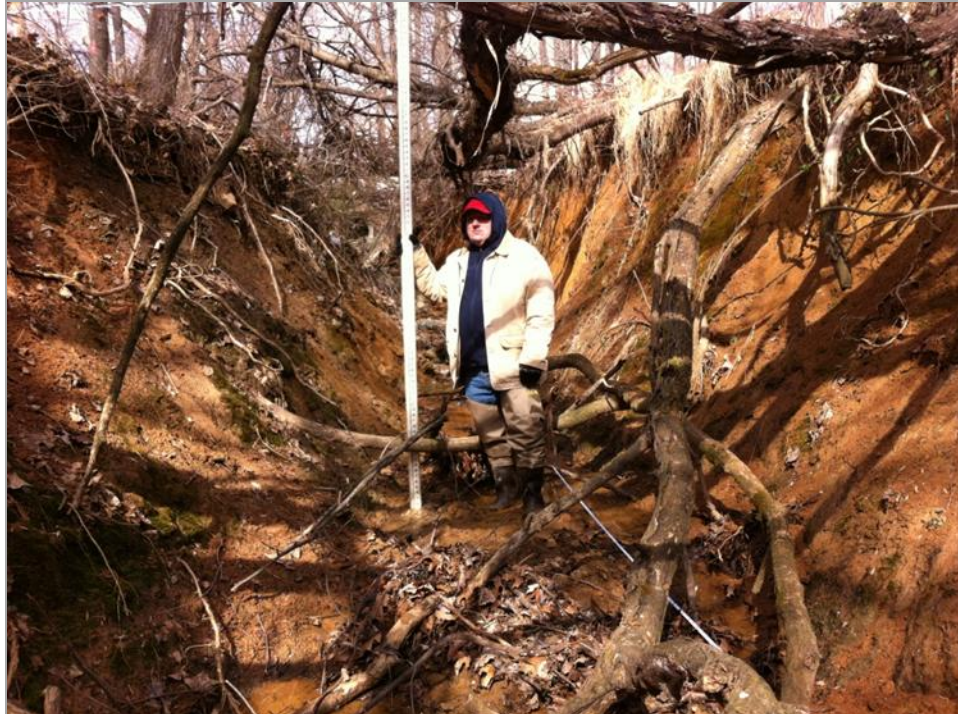
**Figure III.H.8. Upstream View of Sligo Creek,  
Breewood Tributary, Study Area 1- Cross Section 1**

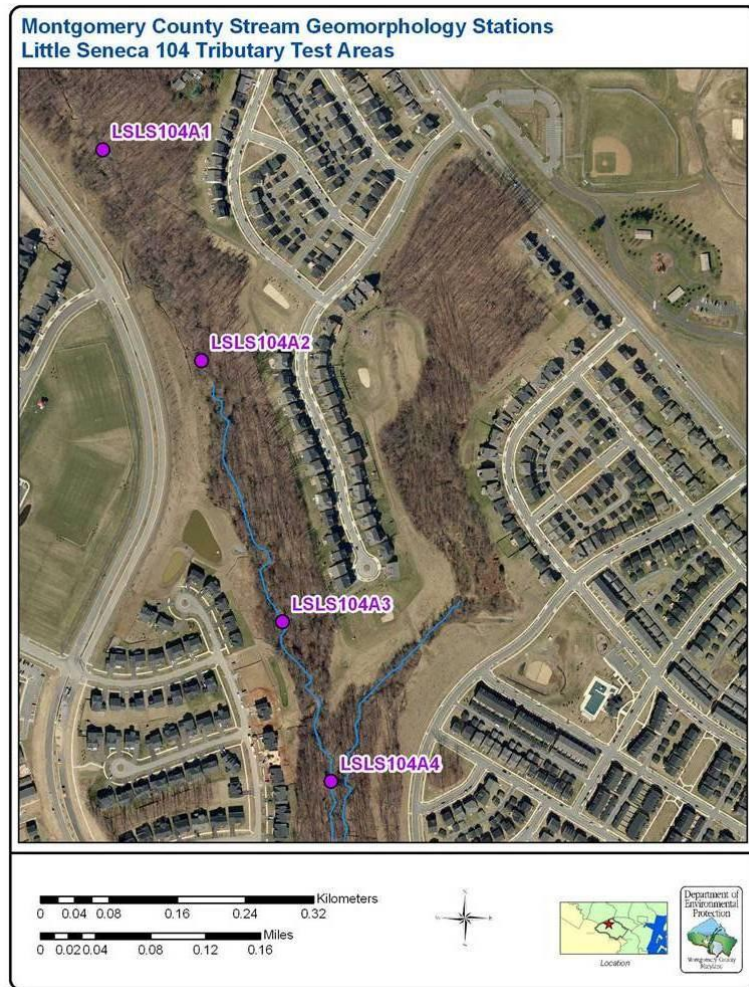
Figure III.H.11. Geomorphology Survey Locations: Test Area (A), Control Area (B)
